## MARINE INVESTIGATION REPORT

M99W0095

CAPSIZING WITH LOSS OF LIFE

*MARABELL 8*

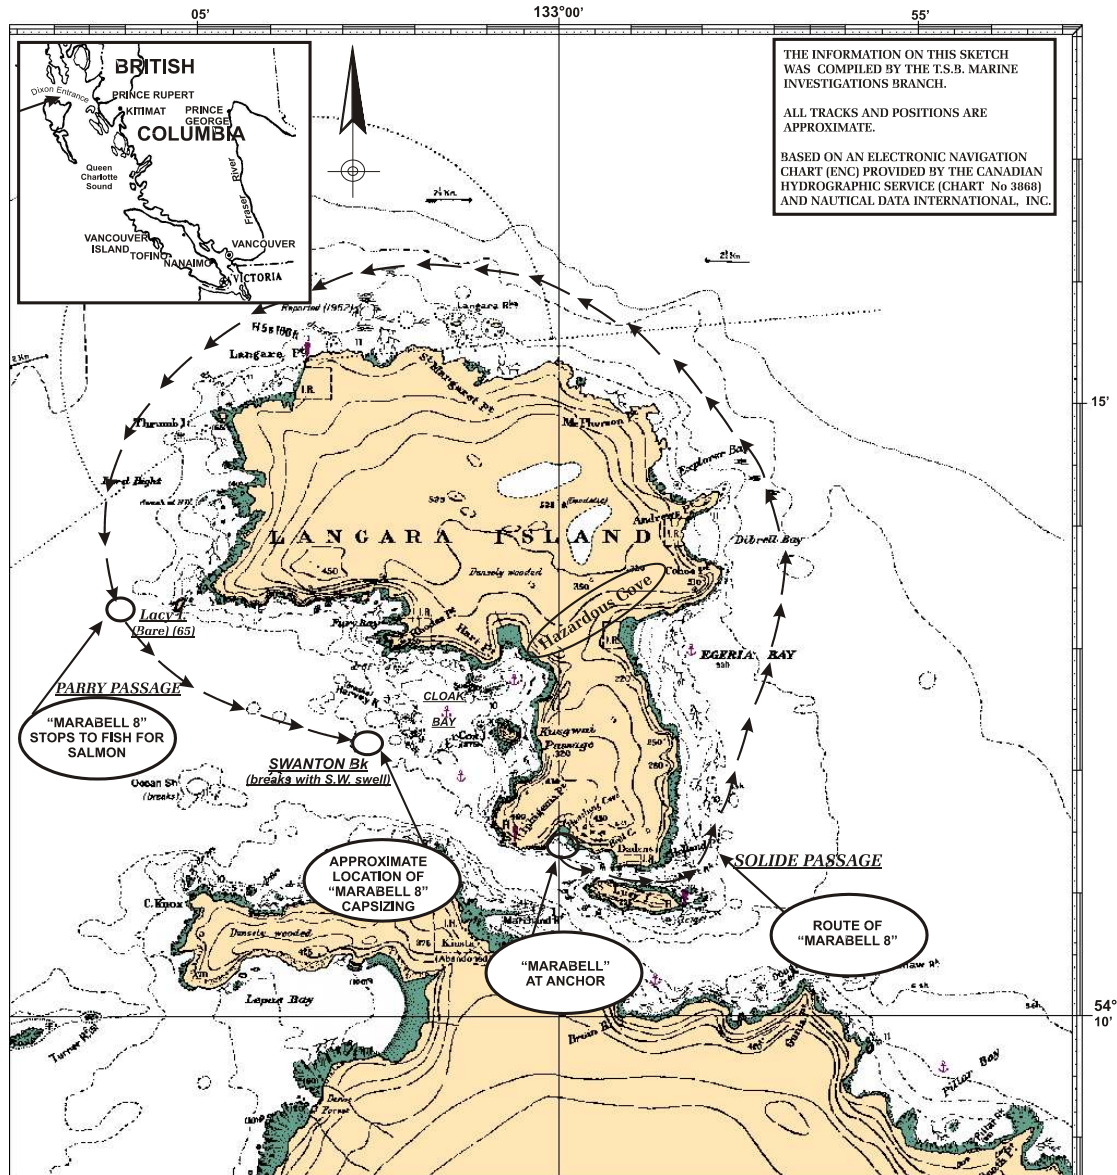
At approximately 0545, they arrived in the vicinity of Lacy Island and cast their fishing lines in the water. Before long, they found that the rain, southerly winds and large waves combined to make fishing very uncomfortable. At approximately 0605, they reeled in their lines and began a passage back to *Marabell* by following a course through the exposed waters of Parry Passage. At approximately 0630, in the vicinity of Swanton Bank, the boat was making a speed of approximately 12 to 15 knots when a large wave struck its starboard side. The boat capsized, throwing both of the occupants into the sea.

Figure 1. Langara Island, British Columbia, showing the route of *Marabell 8* on 29 June 1999
